Ford Full Frames –Straight Talk About Repairs

Several questions surround repair of the Ford F-150 frame.

I-CAR ADVANTAGE

TECHNICAL INFORMATION FOR THE COLLISION INDUSTRY

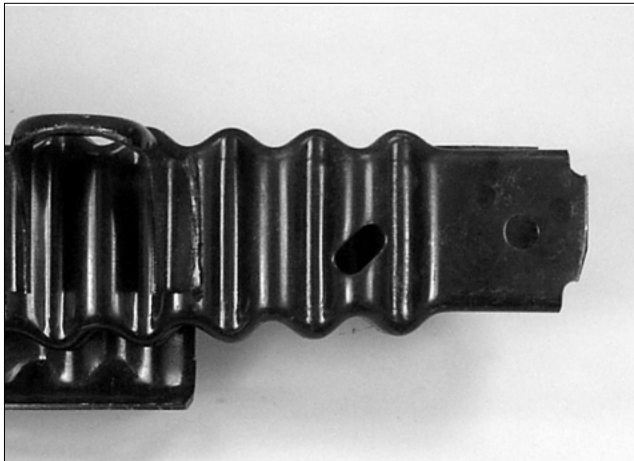
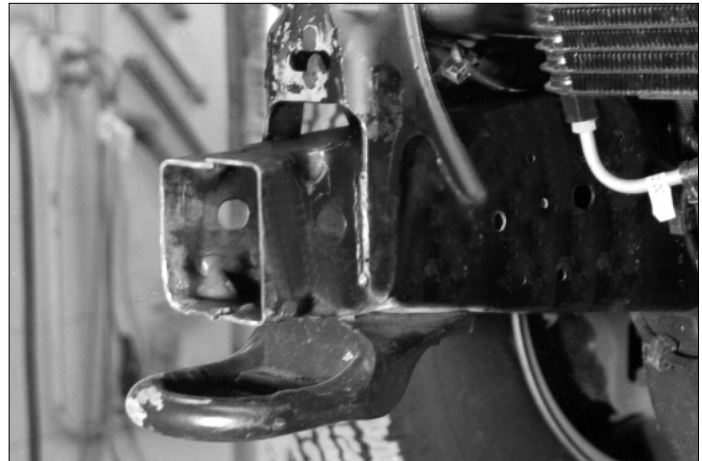
Figure 1— Whether the exaggerated ripples on the pre-1996 frame ends (left) or the more subtle crush initiators (right), the rule is still to not straighten these areas.

That rule is: DO NOT REPAIR CRUSH INITIATORS. This area is from the front to about 600 mm (24") back. If the frame is bent in this area, straightening is not an option. Ford maintains that the integrity of these areas is crucial to proper airbag deployment, and therefore these areas should not be repaired.

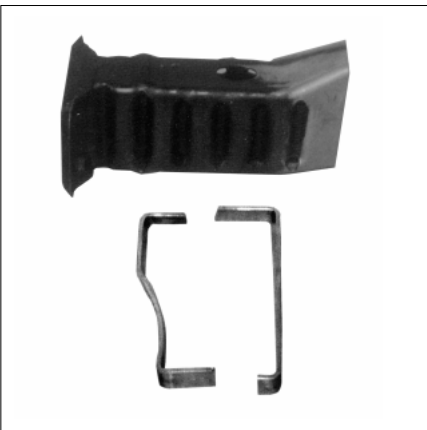
Figure 3—Front frame horn sectioning kit. The small pieces are the butt-joint backing sleeves. (Courtesy of Tech-Cor)

The sectioning procedures sanctioned by Ford (see the timeline in Figure 2) include the front frame horn extensions for the 1992–1995 Explorer, 1992–1997 Ranger, and the 1992–present Econoline van. These right and left replacement sections, which include the front rail convolutions, are available from Ford to avoid replacing the entire frame (see Figure 3).

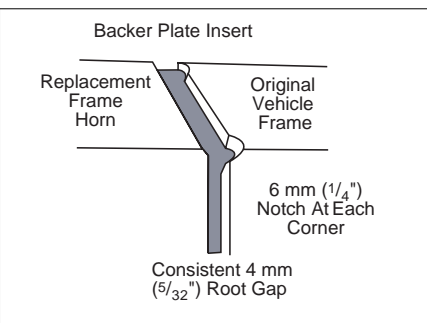
Figure 4—The frame horn kit is installed with a GMA (MIG) welded butt joint with backing. (Courtesy of Tech-Cor)

The sectioning procedure with these kits involves GMA (MIG) welding a butt joint with backing, using backing pieces supplied with the kit (see Figure 4). The thickness of the rail adds requirements to the welding procedure. To ensure proper weld penetration, the rail edges should be beveled all around for a V-groove joint. The root gap should be a consistent 4 mm ($5/32$ "). The GMA (MIG) welder

must be capable of producing 200 amps at a 40% duty cycle. The welding wire should be rated ER70S-3, with a 0.8 mm (.035") diameter. These capacity requirements dictate a 220-volt welder.

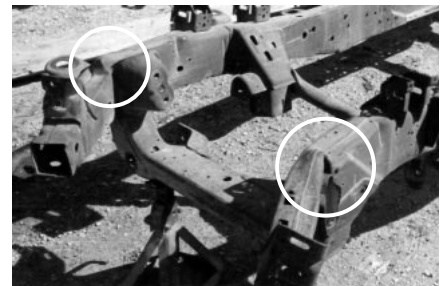
- A **bend** is when the change in the shape of the part, between the damaged and undamaged area, is smooth and continuous, and can be straightened without permanent deformation.
- A **kink** is a sharp bend of more than 90° that can't be straightened without permanent deformation or cracking (see Figure 5).

Figure 5—These folds in the frame rail are classified as kinks and cannot be repaired.

Bends can usually be straightened with little or no heat applied. Kinks will usually tear or crack during straightening. Often a kink is work-hardened to the point where the deformation is permanent. The only repair for a kinked frame member is replacement of the damaged section or complete frame.

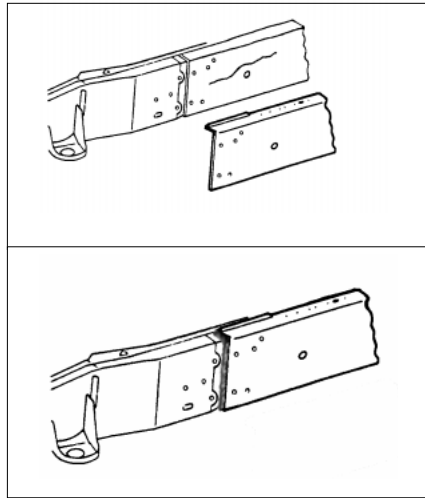
Figure 6—The reinforcement is welded to the outside of the stress-cracked rail. (Courtesy of Ford Motor Company)

The service manual says the reinforcement should be the same material and thickness as the frame member being reinforced. Ideally, the reinforcement should be cut from the corresponding area of a similar frame. Also, the reinforcement should extend 100–150 mm (4–6") to either side of the crack.

The frame reinforcement procedure described in the service manual calls for installing the reinforcement on the outside of the rail (see Figure 6). There is no reference to installing the reinforcement on the inside. The first step is to drill a 6 mm (1/4") hole at a point 12 mm (1/2") beyond the root of the crack.

This is to stop the crack from spreading. You then grind out the

full length of the crack from the backside to form a V-shaped slot, and weld the crack shut. Clearance holes are drilled in the reinforcement, where necessary to clear rivets and bolts. The reinforcement is clamped to the rail and welded to the rail all around its perimeter. Undercoating applied to the outside of the repair provides the necessary corrosion protection.

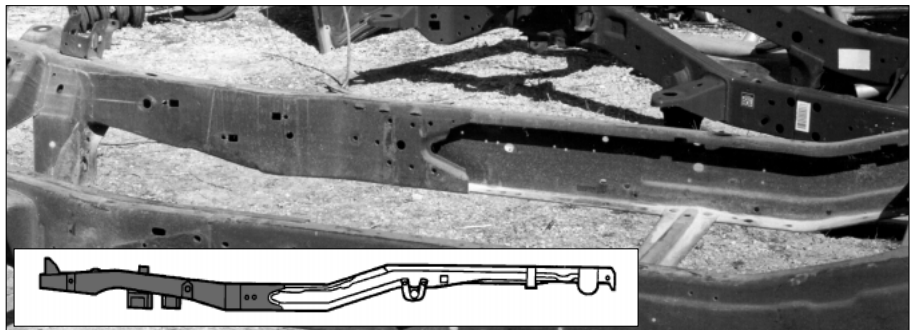
This type of reinforcement repair is possible only on the “C” channel portion of the rails, where there’s full access to both sides (see Figure 7). Fortunately, this is where the stress cracks caused by overloading or fatigue normally occur.

Figure 7—Crack repairs are only possible on the three-sided portion of the rail, which is only about half the frame’s length.

To repair a crack on a closed-frame section, V-groove the crack from the outside. Weld the crack shut, and dress the weld flush with the surface. Apply a reinforcement plate to the outside, just as on the three-sided channel repair. Again, this can only be done outside of the crush initiator area.
