Uniform Procedures For Collision Repair

DT21–Halfshafts

This procedure describes the diagnosis, replacement, and inspection of axle **halfshafts**. Diagnosis, repair, replacement, and inspection of **constant velocity (CV) joints** is also included.

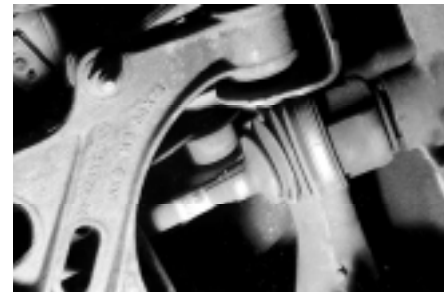
- 1. Remove the halfshaft from the vehicle. See **9.1**.
- 2. Secure the halfshaft in a vise. Avoid overtightening the vise.
- 3. Cut the boot clamps from the joint boot. Replace the boot clamps.
- 4. Scribe a mark on the shaft, at the small end of the boot.
- 5. Remove the boot from the joint.
