Ford Full Frames –Straight Talk About Repairs

Several questions surround repair of the Ford F-150 frame.

I-CAR ADVANTAGE

TECHNICAL INFORMATION FOR THE COLLISION INDUSTRY

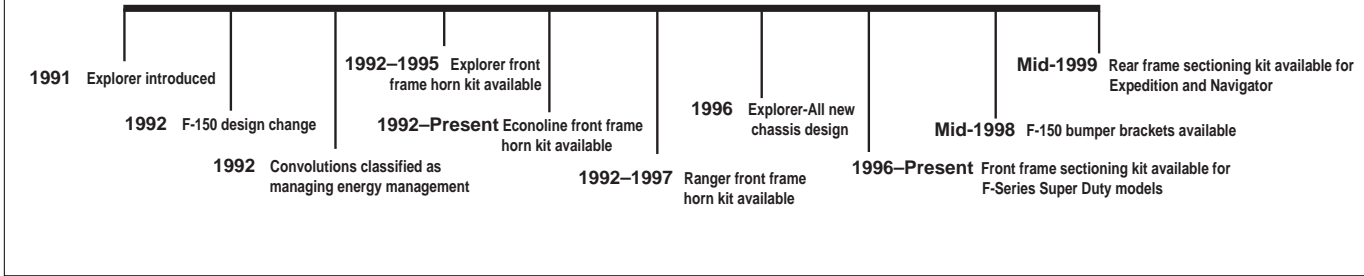
Figure 2—Timeline for the Ford frames.

The sectioning procedures sanctioned by Ford (see the timeline in Figure 2) include the front frame horn extensions for the 1992–1995 Explorer, 1992–1997 Ranger, and the 1992–present Econoline van. These right and left replacement sections, which include the front rail convolutions, are available from Ford to avoid replacing the entire frame (see Figure 3).
